MERRIMACK RIVER BASIN  
CONCORD NEW HAMPSHIRE

## SEWALLS FALLS DAM

### PHASE I INSPECTION REPORT NATIONAL DAM INSPECTION PROGRAM

MAY 1979

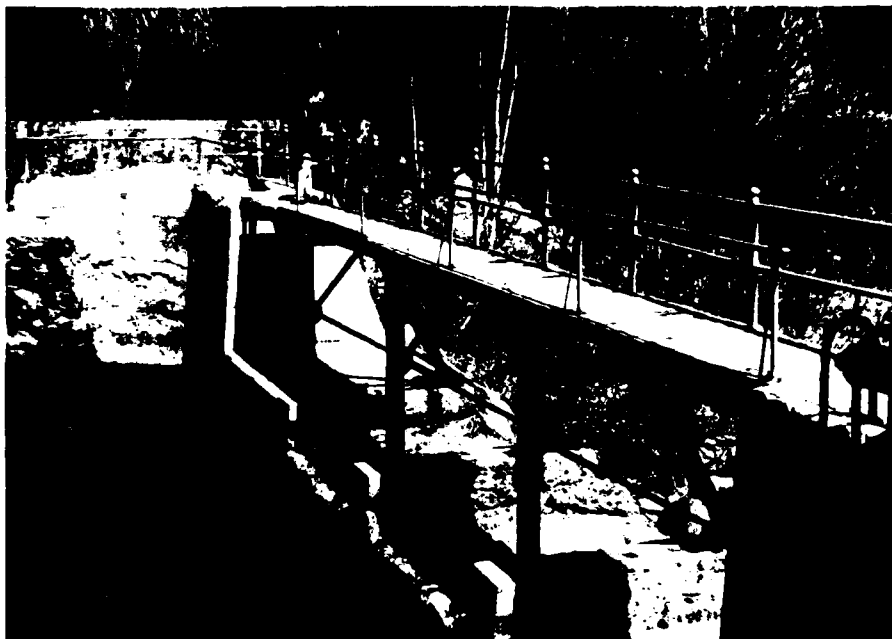
The now abandoned generating station is located at the end of the diversion channel. Visual inspection revealed that all structures related to the generating station are generally in fair to poor condition. The poor condition, as can be seen on Photo Nos. 19, 20 and 22, apply primarily to the 50 foot long waste spillway and service bridge.

c. Appurtenant Structure. Visual inspection of the timber crib/stone fill spillway, abutments with training and cut-off walls, intake structure to the power diversion channel and the now abandoned generating station did not reveal any evidence of stability problems. Abutment fascias with cut granite masonry are in good condition. The concrete surface, with exception of the abutments and cut-off walls, is in fair to poor condition; cracks and heavy spalling were noted on most of these surfaces. (Photo Nos. 2,11,19,20 and 22.)

PHOTO NO. 19 - View of waste weir from power house structure.

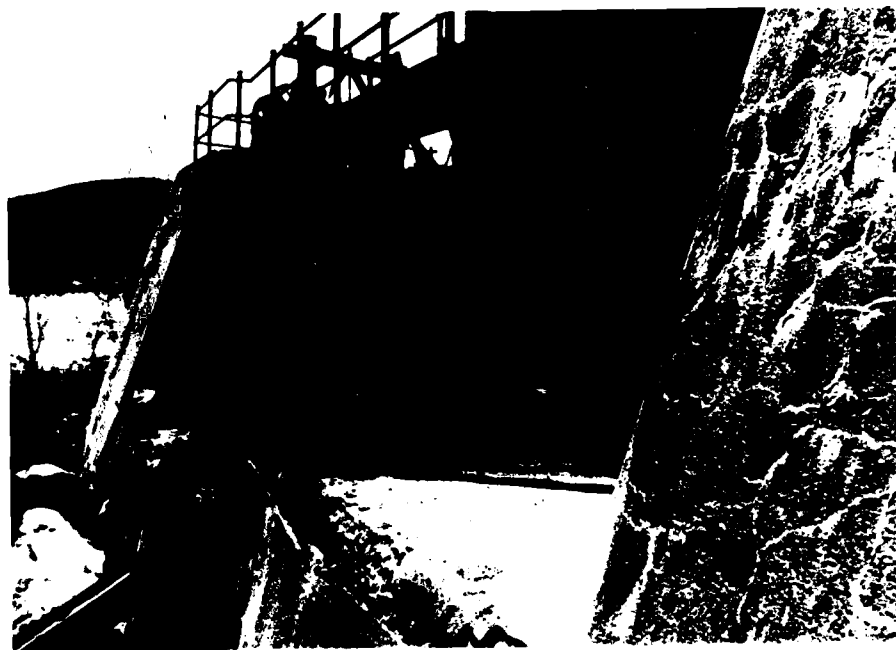
PHOTO NO. 22 - View of downstream side of waste  
weir.
